**Closure of the Idaho National Laboratory Advanced Test Reactor Complex  
Catch Tank and Hot Waste Tank Systems – 10240**

Brett Welty, Sara Verba, Doug Collins  
Portage, Inc., 1075 S. Utah Avenue, Suite 200, Idaho Falls, Idaho 83402  
Donna Nicklaus  
Portage, Inc., 335 Central Park Square, Los Alamos, New Mexico 87544  
Ernie Carter, P.E.  
Carter Technologies Co., 9702 Garden Row, Sugar Land, Texas 77498

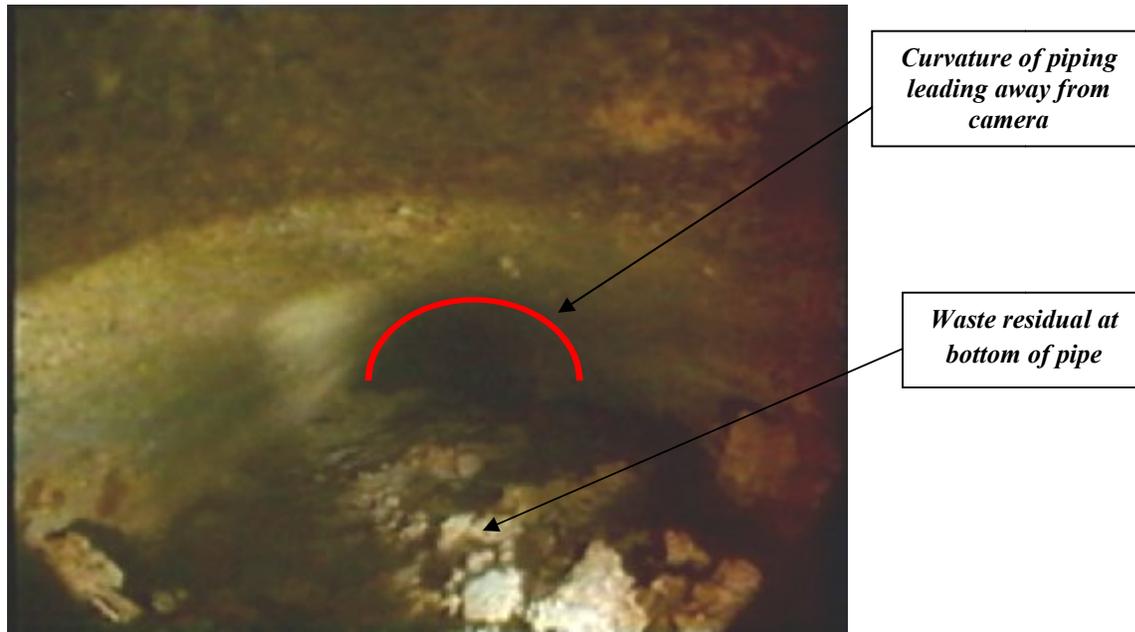
Pipe lines proved to be the most challenging to characterize. Internal radiation measurements were collected by accessing the piping at periodic intervals (which many times required excavation) and pushing a rate meter (AMP-100 or similar) into the piping using a push rod. In other cases, pipes were characterized by inserting thermoluminescent detectors (finger rings) into the pipe for a set period of time and then counting the detectors. Video of piping was also completed, using both wheeled robots and push rods. An example of the piping challenges faced by the project can be seen from a resultant video capture as presented in Figure 1.

Fig. 1. Hot Cell #1 Drain Header during April 1, 1998, Video Inspection.

Piping within the vaults and outside the vaults buried in soil contains significant hold-up or residue as can be seen in Figure 1. Sampling and radiological analyses of these residuals indicates the presence of significant quantities of gamma- and alpha-emitting isotopes. A typical sample result is presented in Table I.

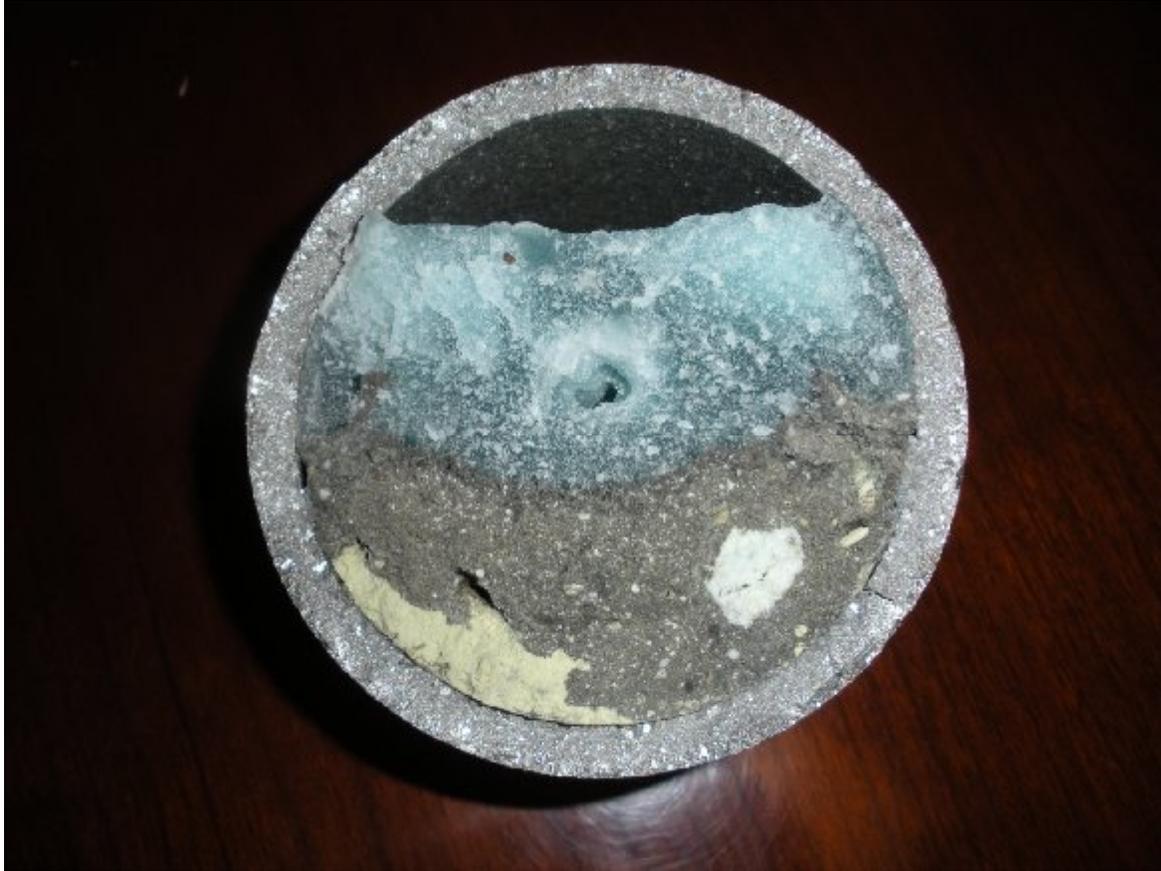
The VCO Project evaluated Carter Technologies' molten wax product, Waxfix™. This molten wax can permeate soil, rock, and other material to render the material waterproof and non-dusty. The evaluation included jar tests; a transparent model test (small-scale mockup using 3 m of 8-cm inside-diameter borosilicate glass tube with a 90-degree-long radius upward sweep on each end); a limited-scale mockup (one 2-m-long, 10-cm Duriron pipe with 90-degree bends on each end); and one full-scale mockup (loop of six Duriron pipe segments, two half segments, and six bends). Six types of surrogate materials were used in the full-scale mock-up: (1) bentonite powder with a concrete cap; (2) dry lime with a sodium silicate hard cap; (3) dry mixture of cement, sulfur, plaster, and flyash with a sodium silicate hard cap; (4) dry cement with a sodium silicate hard cap; (5) dry cement, bentonite, and slag with a sodium silicate hard cap; and (6) high-strength concrete made with sand cement bentonite grout. The molten wax permeated all of the surrogate materials in each of the pipes, except for a portion near the end of the pipe that contained the high-strength concrete surrogate. The blue dye in the wax penetrated only a short distance compared to the base wax, which is transparent. This testing indicated that molten wax would be effective for stabilizing the waste inside the piping [9]. The project selected the wax fixative as an appropriate technology for integrated testing (see Figure 2).

Fig. 2. Waxfix Penetrated through the Dry Cement to Fix the Bottom Layer of Dusting Sulfur.

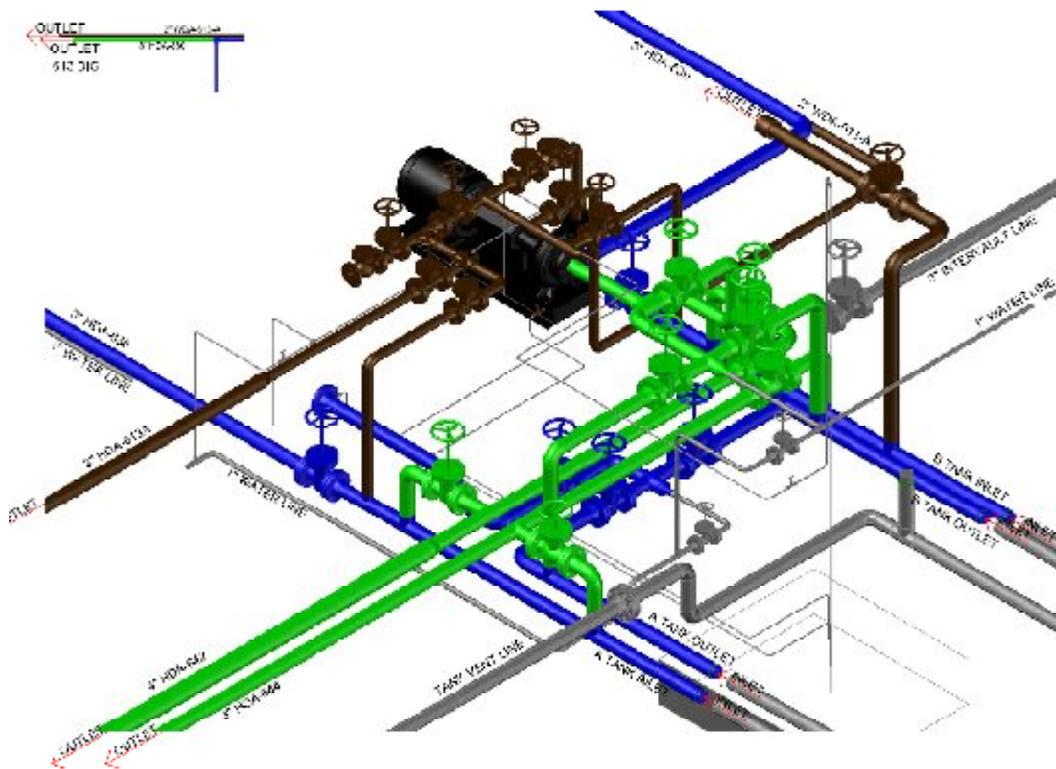
Prior to fixative insertion, the vault was heated to a temperature of around 60°C to heat the piping components, and the Waxfix was heated to a temperature of 82–93°C to assist in the proper flow and penetration of the fixative. Thus, Waxfix flowed through the piping as a liquid. A hand pump was then used to pump the Waxfix through the lower-elevation piping to upper elevations until the fixative was present at all outlet standpipes. Total elevation change from low-point insertion locations to high-point vents was approximately 3 m. Once waxing operations commenced, the insertion process took less than 2 hours. To ensure enough wax was present to completely fill all piping, four 208-L drums were heated and prepared for use. All outlets and the vent location were fitted with high-efficiency particulate air filters and standpipes above ground to monitor the outlets for fixative. The outlets and vent location were left open to allow the air in the pipes to escape as the Waxfix filled the pipes until it was evident that the fixative reached all piping necessary. Vault heaters were shut off once Waxfix was present at all outlet standpipes. As the Waxfix cooled, it solidified to its final wax consistency prior to pipe removal. Step-by-step procedures and drawings [12] were prepared to detail the points of insertion, required vent locations, and equipment setup associated with inserting the Waxfix, and to ensure that Waxfix would fill all necessary piping. These procedures were used in the field to ensure the wax fixative was inserted to the extent practical. Figure 3 provides an example of one intermediate wax insertion step for the TRA-613A vault. This figure shows the anticipated flow of fixative through the piping based on elevation differences and pipe location. Green indicates components currently receiving fixative; blue indicates components in which fixative has already been inserted; and brown indicates components that have not yet received fixative.

Fig. 3. Isometric View of Vault during Waxing.

During waxing operations, remote-video cameras were placed in-vault to monitor for wax leakage. Due to the exceptional permeating ability of the wax, it was expected that flanges with missing or badly damaged gaskets would leak. The remote-video cameras did indeed show leakage from several damaged gaskets. In two instances, the leakage was bad enough that it would have prevented filling the pipe network had it continued. As a result, several valves were closed isolating the leaking section of lines, resulting in a small portion of the piping network that remained being un-waxed.

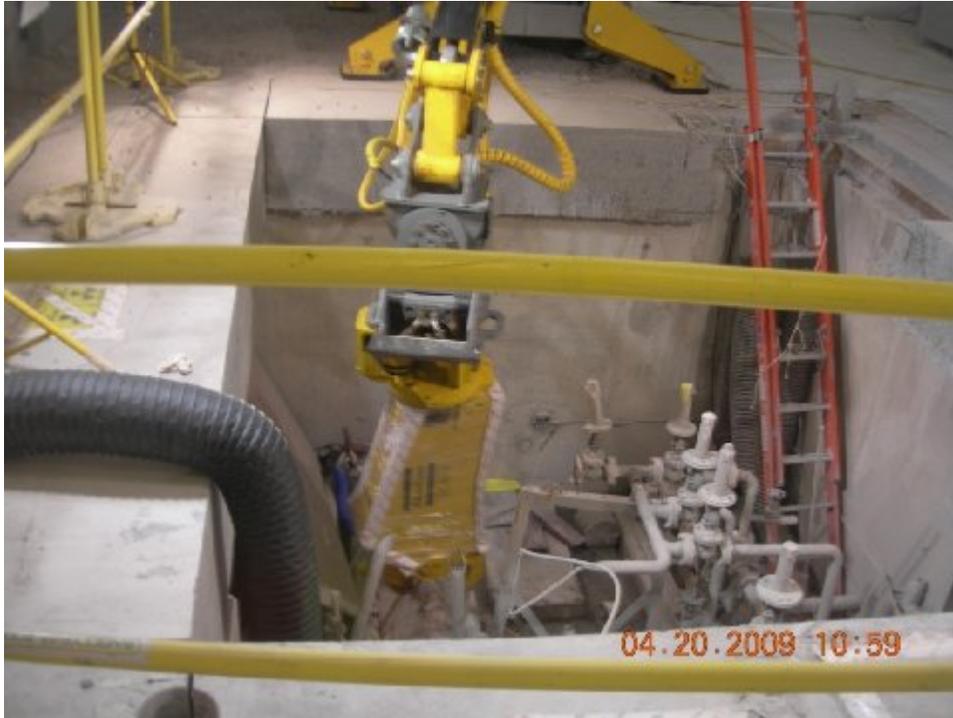
Once the roof was removed, a radiological containment  $12 \times 12 \times 4$  m was erected. The Brokk 330 with a shear attachment was moved into the radiological containment. The operator position was established on a scissor lift so that the platform could be elevated to allow the operator to see not only the video screens, but also the tool within the vault. Three remote-video cameras were placed within the containment to allow perspective views of the shear in relation to vault piping and obstructions. Once operations were initiated, the vault piping removal was accomplished in a single day of operations.

The wax coupled with 3M Firedam external fixative proved to be very effective contamination control. Smearable contamination within the vault prior to fixative application was as high as  $300 \mu\text{Gy/hr}$  [13]. Smearable beta/gamma contamination on jaws of the shear after completion of piping removal averaged  $37 \text{ Bq}/100 \text{ cm}^2$ . Smearable beta/gamma contamination within the enclosure following pipe removal averaged  $65 \text{ Bq}/100 \text{ cm}^2$  [14]. Brokk operations are illustrated in Figure 4.

Fig. 4. Brokk 330 Demolition Robot in Operation at the TRA-613A Vault.

The Brokk 330 demolition robot was successfully used to remove piping, pumps, valves, and miscellaneous scrap metal from the TRA-613A vault. The shear attachment proved to be the most useful of the end effectors used by the project. The shear was capable of easily sizing the 5- and 8-cm piping contained within the vault and could also be used to grasp and retrieve cut segments of piping.
